# I 9,11/12, Casa di Amarantus

## *Plasters and phases*

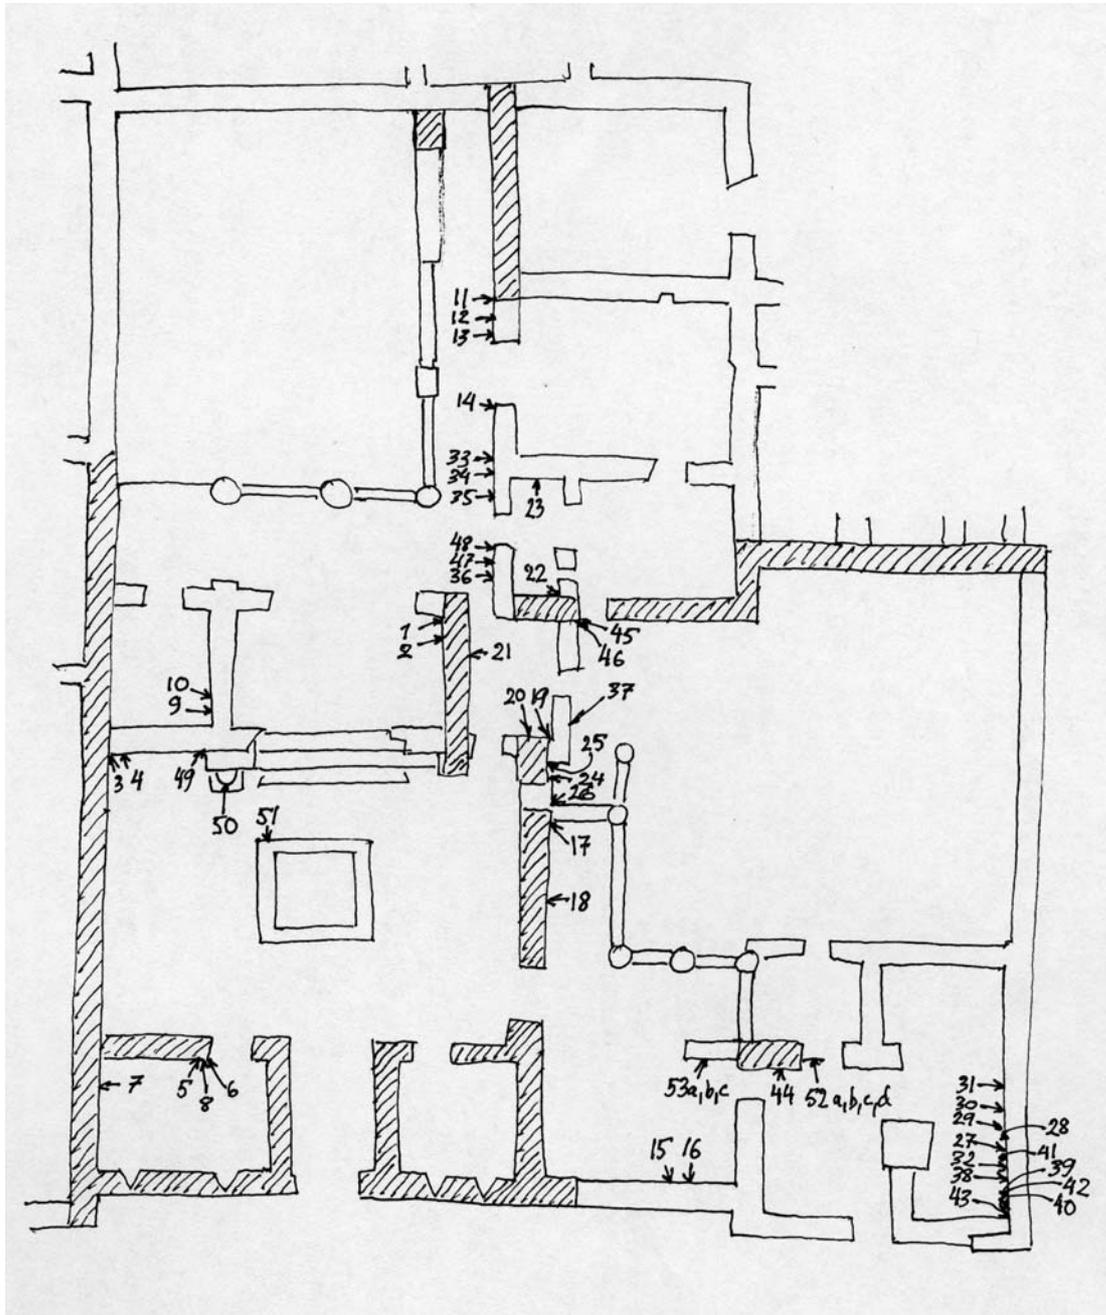
Fig. 21. Casa di Amarantus. Sampling areas.

Sampling started in house 12, where a 1<sup>st</sup> style painting remains below the level of the raised floor in the *tablinum*, room 5, (*Fig. 21*). It was made on a plaster belonging to group A. The 4<sup>th</sup> style decoration above the subsequently raised floor was made on a plaster belonging to group G. Belonging to the same period is the decoration in room 7, also here covering remnants of the earliest phase.

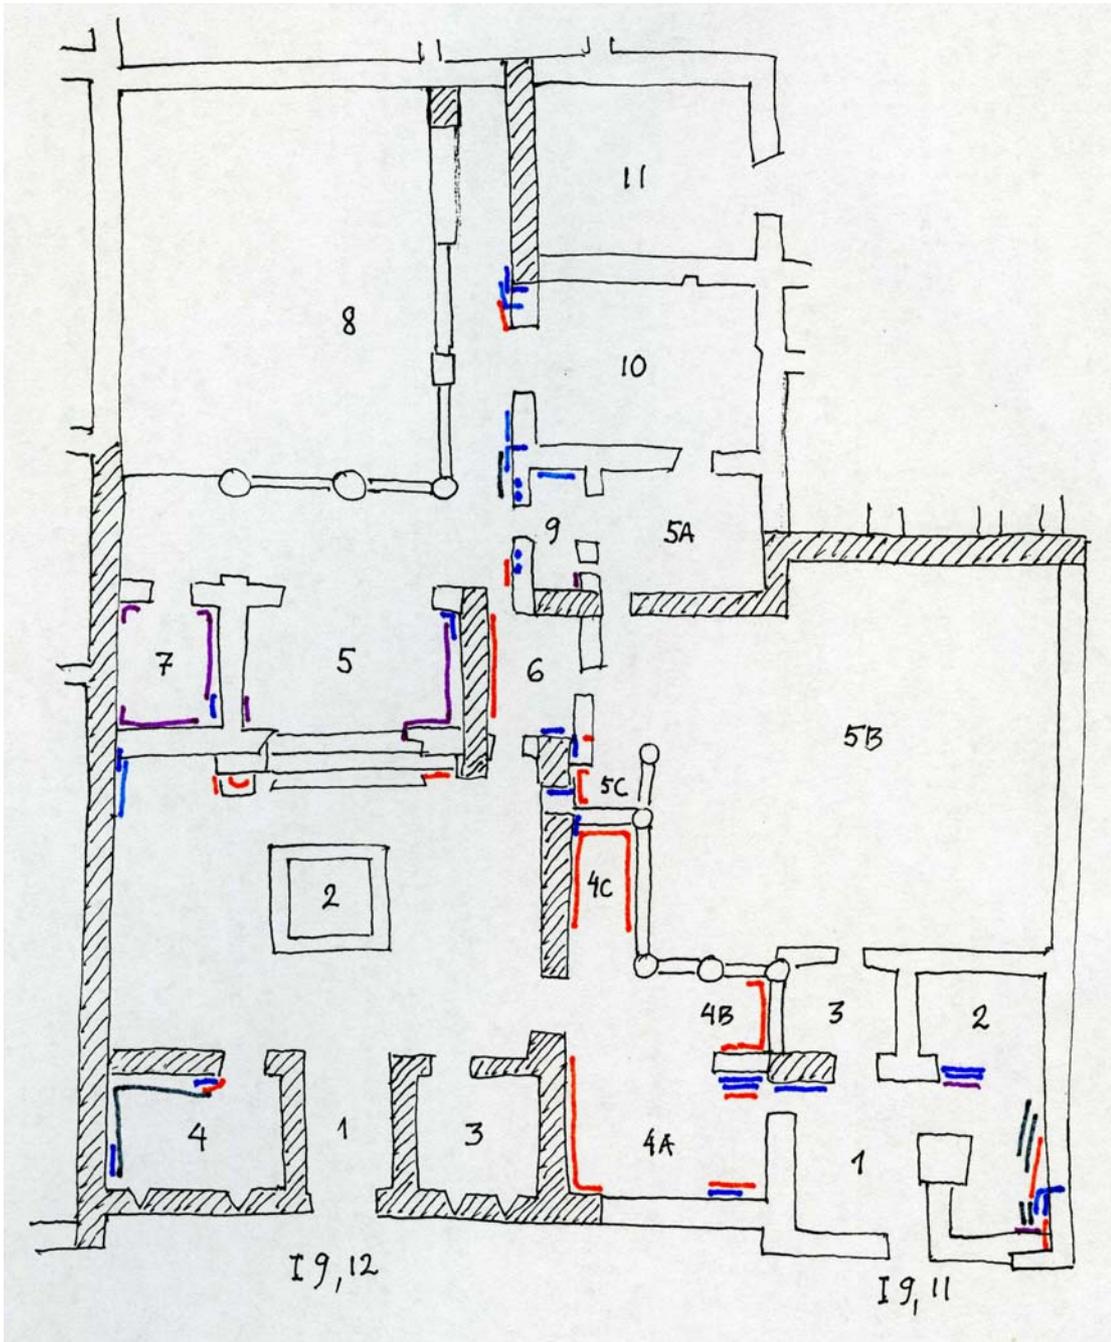
Fig. 22. Casa di Amarantus. Colour code.

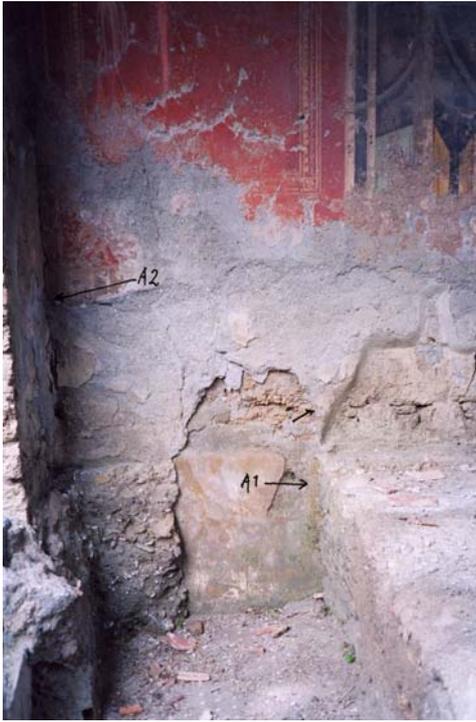
Fig. 23. To the left: Room 5, *tablinum*. 1<sup>st</sup> style decoration concealed by a 4<sup>th</sup> style painting.  
 Fig. 24. To the right: Room 2, atrium. Plaster layer on the west wall, trapped behind the north wall.  
 Fig. 25. Below: Room 8, peristyle area. Sampling areas.

*Last phase:* type A 2, group G. East, south walls, and part of west wall: 4<sup>th</sup> style decoration on covering type A 1.

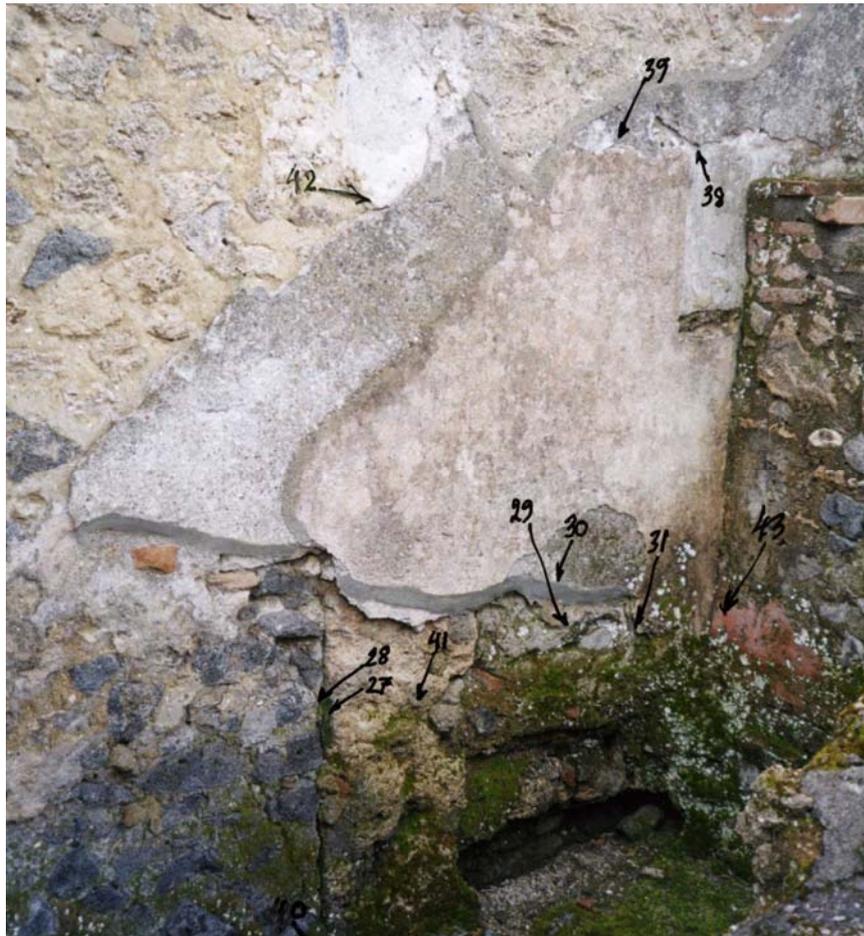
Fig. 26. House 11, the bar. Sampling spots and plaster groups: sample 27 = group A, 28 and 40 = B, 38 and 42 = E, 29 = G, 30 = H, 31 and 39 = H. Sample 43, on the south wall, plaster group G.

In house 11, room 1 and its complex east wall and bar area, has been in focus (*Fig. 23*). This is the place where all plaster types in the house were represented, indicating that the room had been subject to several changes and redecorations. The earliest phases are represented by the two early plasters A and B, which raises questions. The results of the study on the standing structures show that the east wall was constructed later.<sup>4</sup> We have been discussing this matter, and it is not my intention to contradict the archaeologists, but since the plaster is there, there has to be an explanation. The earliest plaster, A, appears as a small remain on a large Sarno stone block, concealed by the later, B. There is also a layer of plaster B below the level of the raised floor. Plaster A can be explained

as a remnant on a block that was reused in the wall. Plaster B may also be there accidentally, or there may be remains of an earlier construction below the present wall at the southwest corner.

In any case, the early plasters A and B are covered by a red and white 3<sup>rd</sup> style decoration, plaster group E. This decoration continues behind the step-like construction at the bar counter that is located in the southeast corner. The “steps-construction” was decorated with a plaster belonging to group G, also used for the 4<sup>th</sup> style decorations in rooms 5 and 7. Finally, the east wall was redecorated with a reused sandy plaster, H, which contains crushed materials such as glass and ceramics. This layer should be dated to post AD 62. There is one more partial plaster application of a slightly better quality, which has a red top layer consisting of lime and *cocciopesto*. These final applications are almost identical, and belong to the same group of reused plasters, H. They are, however, noted as two plaster types, simply because one is covering the other.

*Earliest phase:* type A 1, group A. North wall: layer at the socle, and east wall, plaster remains on a standing block.

*Second phase:* type A 4, group B. East wall: layer in the blocked door, continuing on the wall, covering type A 1.

*Third phase:* type A 6, group E. East wall: white plaster layer with white and red decoration, which continues behind a brick construction (bar).

*Fourth phase:* type A 2, group G. East wall: pinkish red layer with pick-marks, covering type A 4 and covered by plaster type A 8.

*Fifth phase:* type A 8, group H. East wall: plaster with inclusions of glass, ceramics, marble etc. layer covering type A 2.

*Last phase:* type A 31, group H. East wall: layer covering type A 8.
