I 9, 1 Casa del Bell'Impluvio

Plasters and phases

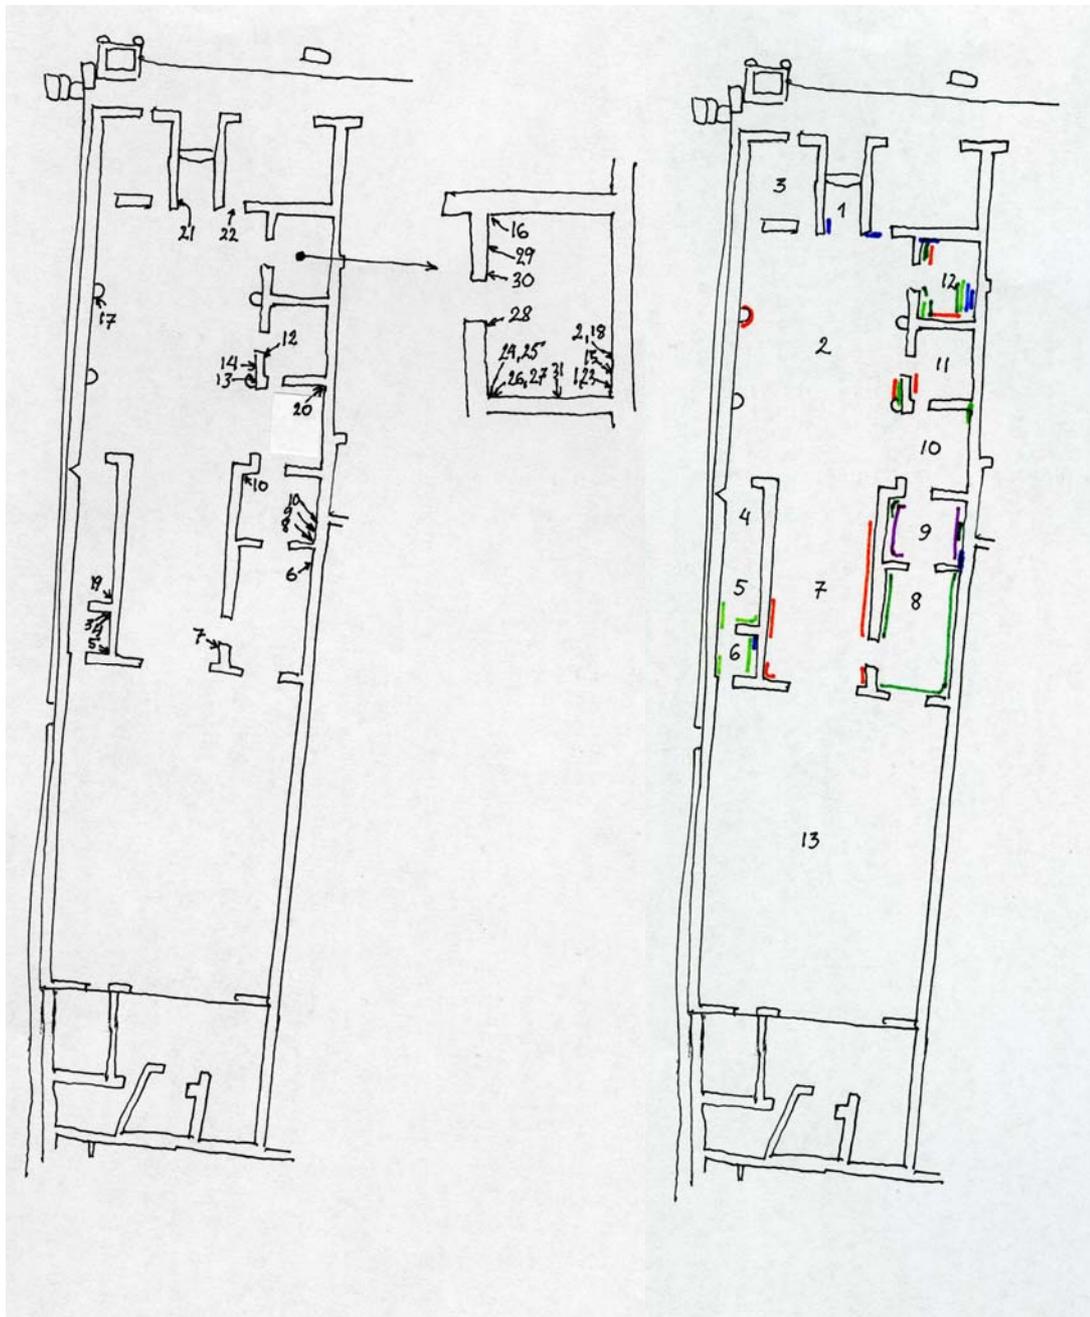
Fig. 11. Casa del Bell'Impluvio. Sampling areas and colour code.

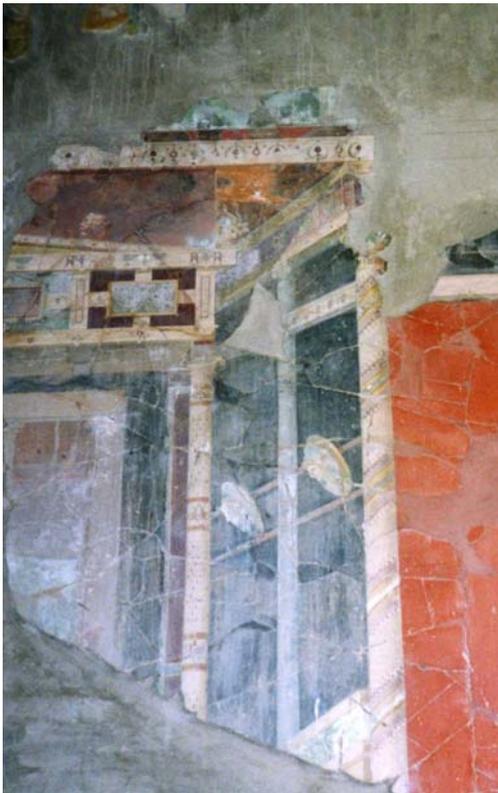
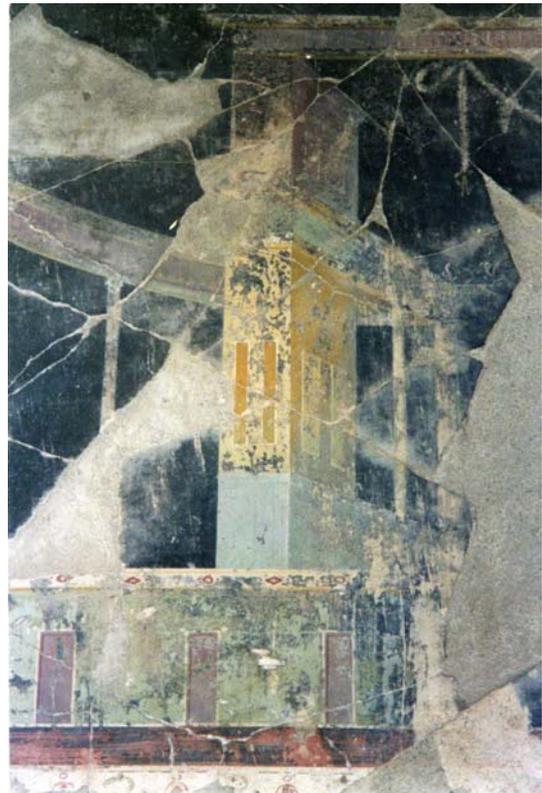
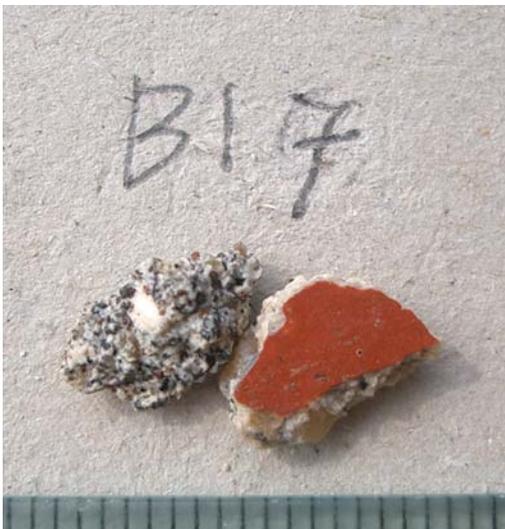
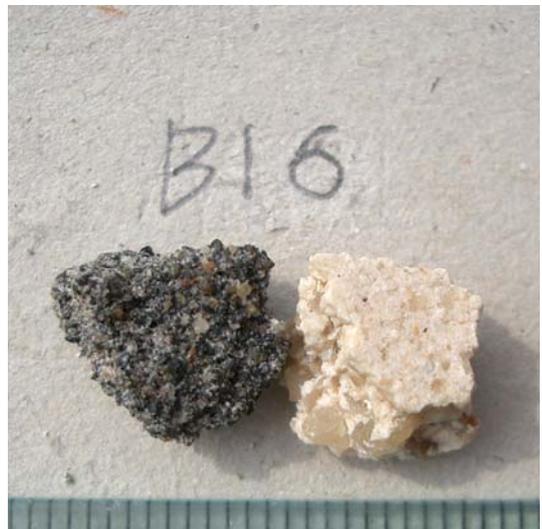
The 3rd style decorations in rooms 7, *tablinum* and 8, the black *triclinium* had been made on different kinds of plaster (*Fig. 12*). The *tablinum* filler was large-grained with brilliant colours and crystals, imbedded in an abundance of lime.¹ The decoration in the “red” room 11 and in the atrium was made on this kind of plaster. The *triclinium* plaster had little lime, extremely fine grains and lots of crystals, making the plaster look dark and compact. In room 9, previously part of room 8, there were remains of the *triclinium* decoration, partially concealed under a later phase, a late 4th style redecoration.

Fig. 12. Above: To the left. Decoration in the *tablinum*, detail. To the right: *triclinium* decoration, detail. Below: To the left. Plaster type B17, taken from the *tablinum* decoration. To the right. Plaster type B16, taken from the *triclinium* decoration.

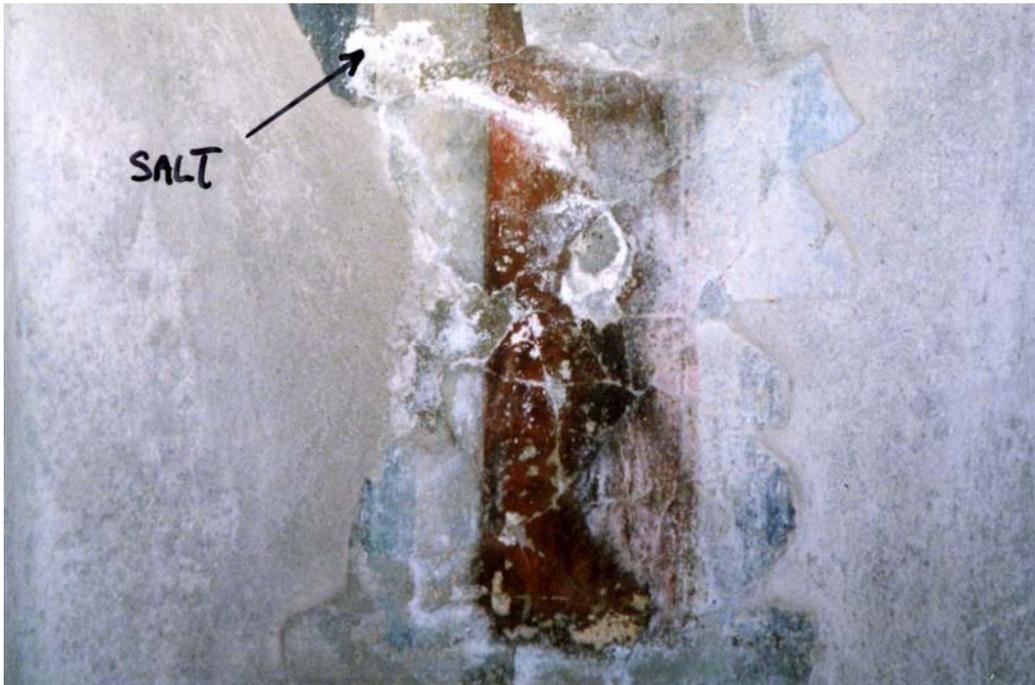
Fig. 13. Salt efflorescence on the east wall in the *triclinium*.

The east wall in the *triclinium* is an example of what happens to wall paintings when exposed to cement, acrylics and humidity (Fig. 13). The salts that penetrate the plaster settle on the painted surface and a thin layer, a veil, is formed. The veil becomes a milky layer, which in turn becomes a salt crust. Salts corrode marble and wall paintings. Salt veils, milky layers and crusts cover most of the east wall decoration in the *triclinium*.⁸ Remains of the same decoration in room 8 are still in good condition, in spite of being badly treated in antiquity; they were picked with a hammer and imbedded in plaster when the room was divided and redecorated. Decay, due to restoration materials is detectible also in the little red cubiculum with the erotic scene, which was noted already in 1981.⁹ These walls were covered with a protective acrylic layer, which captures the smooth and lustrous surface behind a hard and shiny plastic layer.

⁸ A sample of the salt layer (sample BI 6 sali) was analysed at the CNR-ICVBC. Constituted principally by thenardite Na_2SO_4 , it had traces of gypsum and sulphates with sodium and calcium aphthalite, $(\text{K}_3\text{Na}(\text{SO}_4)_2)$; syngenite $\text{K}_2\text{Ca}(\text{SO}_4)_2 \cdot \text{H}_2\text{O}$.
