I 9, 5 Casa del Frutteto

Plasters and phases

I 9, 5 Plaster types, groups, locations

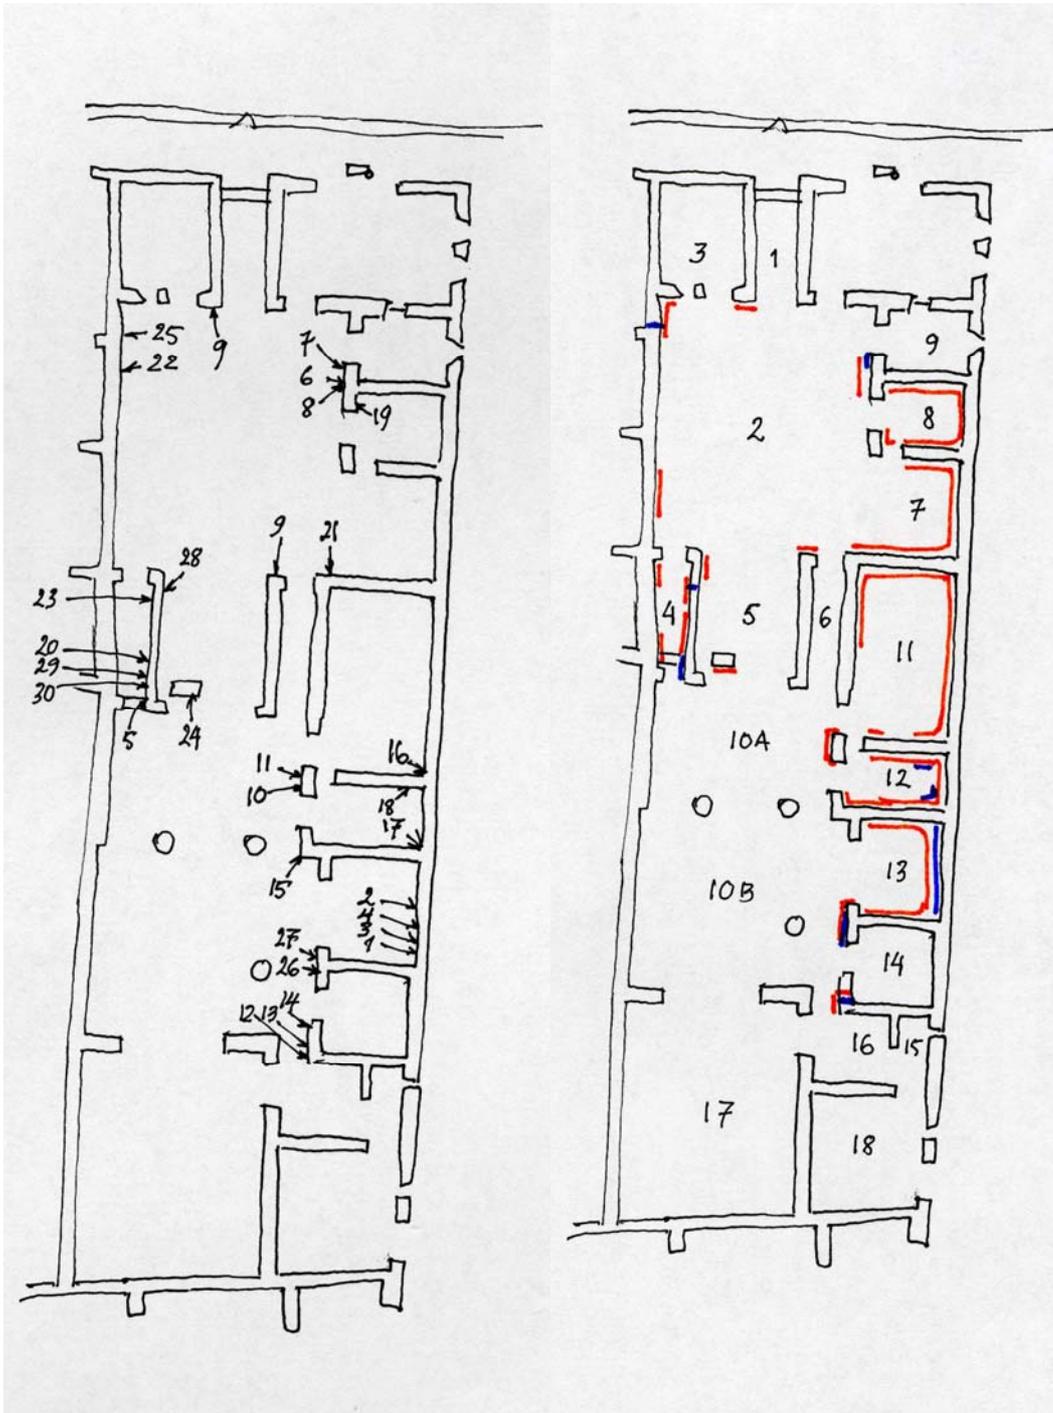
Fig. 17. Casa del Frutteto. Sampling areas and colour code.

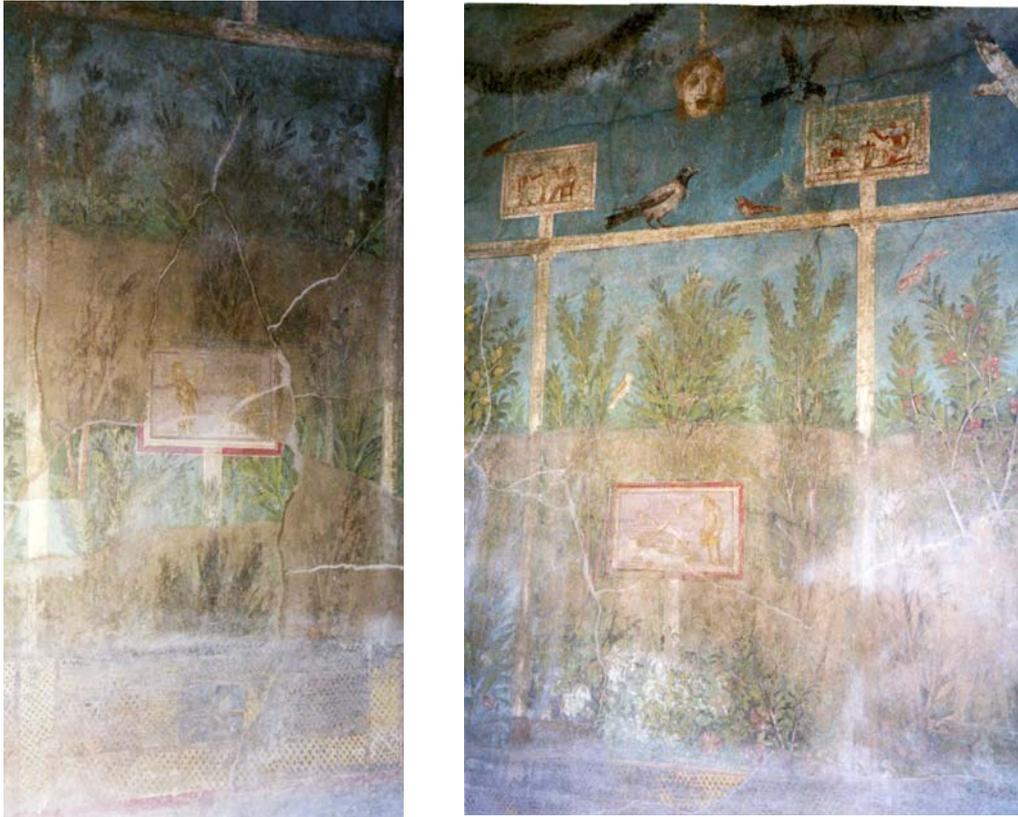
Fig. 18. Room 8, the blue *cubiculum*. Details, showing surface changes.

Unfortunately, the blue room has undergone a disastrous transformation, leaving few areas for contemplating the beauty of colours and composition. Could this be the result of a modern restoration? An opaque white film is spreading over the lower parts of the walls in the room with the fig tree – or are the colours just gradually fading, bleaching away? This room has been restored not too long ago. Summing up, this house was originally decorated with 1st style plasterwork. There is no indication of any changes until the house was redecorated with 3rd style paintings. Modern restoration materials ought to be removed – if possible.

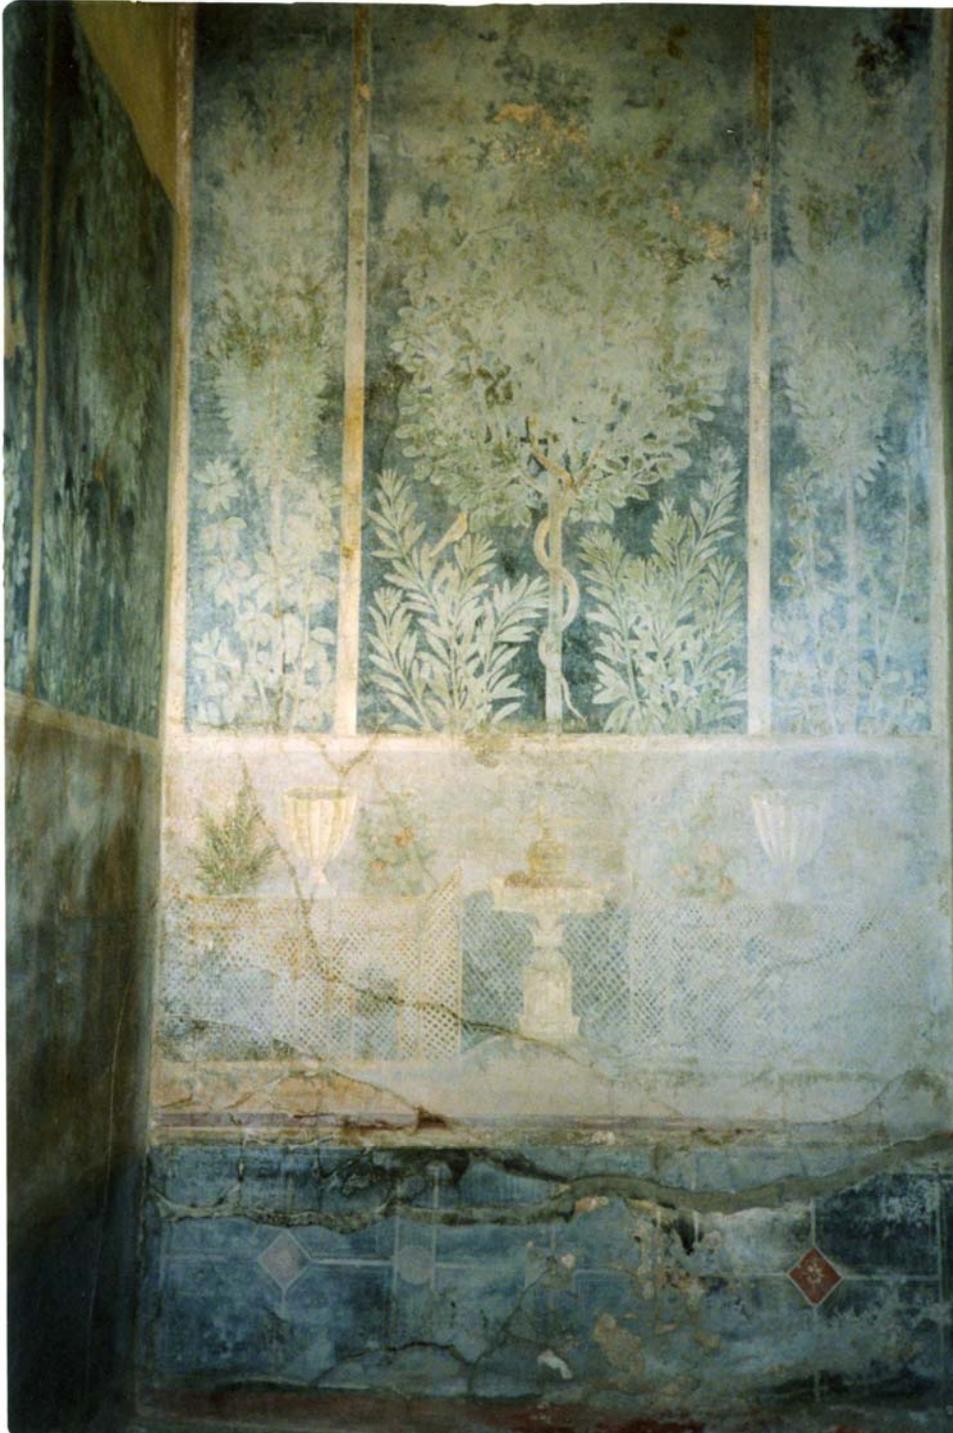
Fig. 19. *To the left*: Room 11, the east wall, detail.

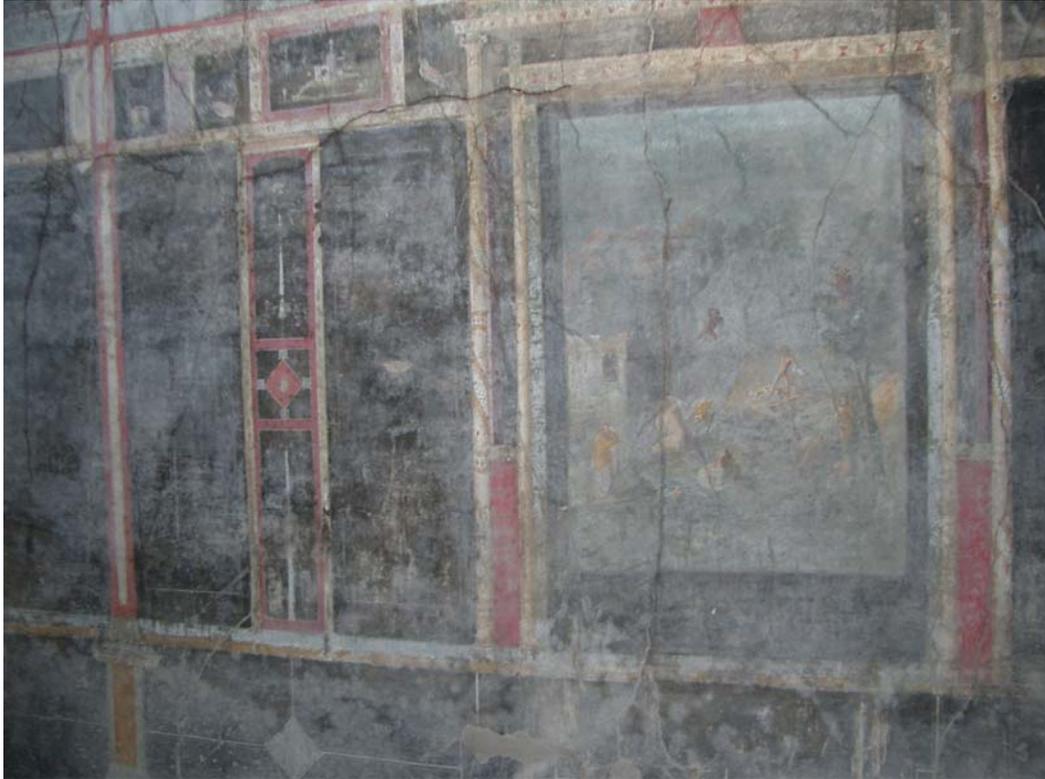
Fig. 20. *To the right*: Room 12, the east wall, detail.
