# Introduction

The present study concerns materials used for Pompeian wall paintings.<sup>1</sup> In focus are plasters serving as preparations for painting. My earlier experiences in the field of ancient and traditional materials and technology led to the hypothesis that technology reflects not only the natural resources but also the ambitions within a society, a moment in time, and the economic potential of the commissioner.<sup>2</sup> Comprehending ancient technology, reconstructing and using it, would be an advantage in modern constructions as well as for the preservation of excavated wall paintings. Consequently, my starting point was to understand Roman plasters from a practical and technological point of view. Later, I studied plasters in Pompeii for two years within the Swedish archaeological project, which led to the conviction that specific characteristics are linked to plasters, used over time, in Pompeii.

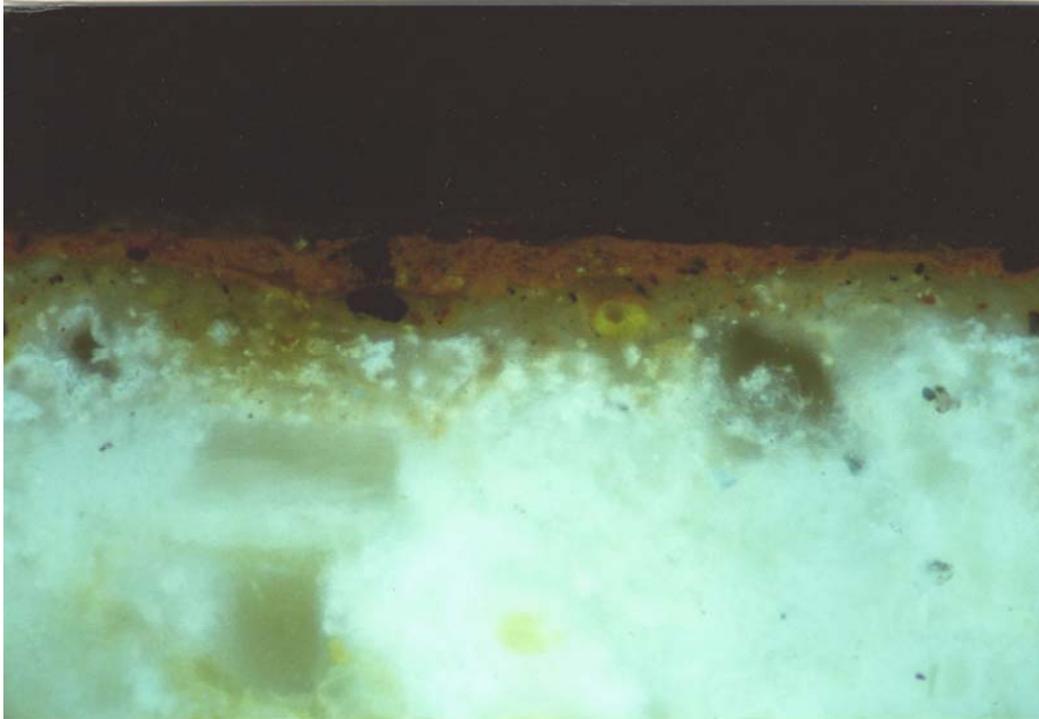
Fig. 1. *Above*: Fragment VL 44A. Sample 32, taken at the red decoration. Grains of red ochre and of carbon may be observed in the upper cinnabar red paint layer as well as in the half transparent layer of beeswax, observable between the paint layer and the preparation.

Häfner followed by including polymers in some preparations for painting. Polymers are not mentioned in the evaluation of the results, but the mixture of grain sizes in the plaster and *intonaco* was considered to be of utmost importance. The conclusion was that *intonaci*, prepared of fine marble dust, became dull while those “...which were composed of coarser material were quite easy to polish and produced an acceptable sheen...”<sup>8</sup> Plasters that have a variety of particle sizes remain as densified compounds after compression, while fine aggregates do not withstand pressure.<sup>9</sup> Häfner’s observation corresponds with my own experiences, e.g., at the Villa of Livia, an investigation of decorated plasters from the period of the Roman Republic to the third century AD.<sup>10</sup> Early preparations, and in particular those of the Augustan period, were of an excellent quality, made of several layers with successively finer grain size. The smooth and lustrous *intonaco* or stucco had inclusions of large crystals of marble or alabaster, a fact already noted by Cagianò de Azevedo<sup>11</sup> (Figs. 1, 2).

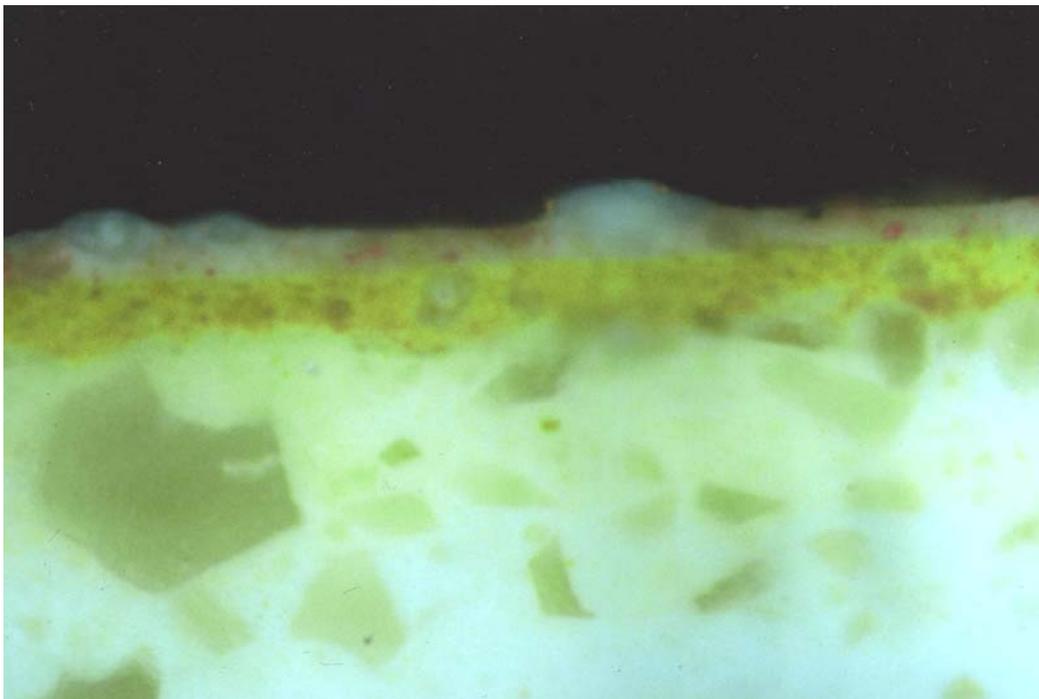
Fig. 2. *Below*: Sample 34, taken at the ochre decoration. Grains of red ochre appear in the paint layer. Calcite and alabaster crystals are present in the preparation. *Photos*: Opificio delle Pietre Dure.

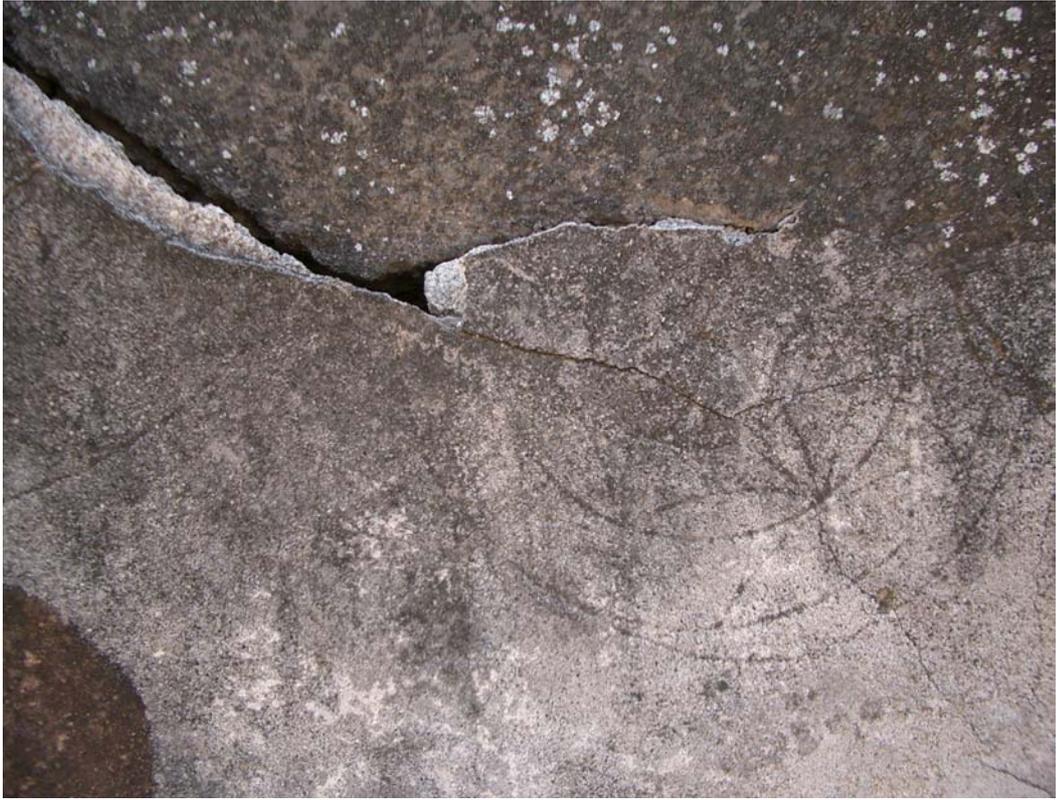
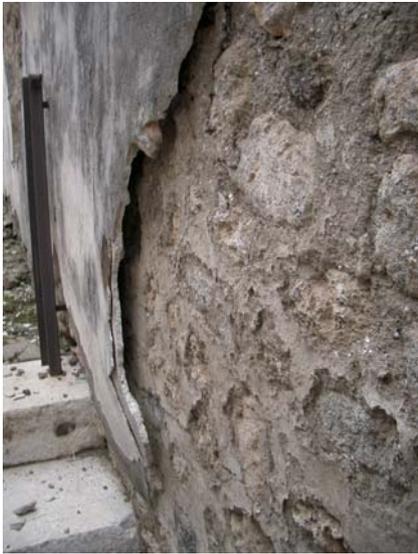
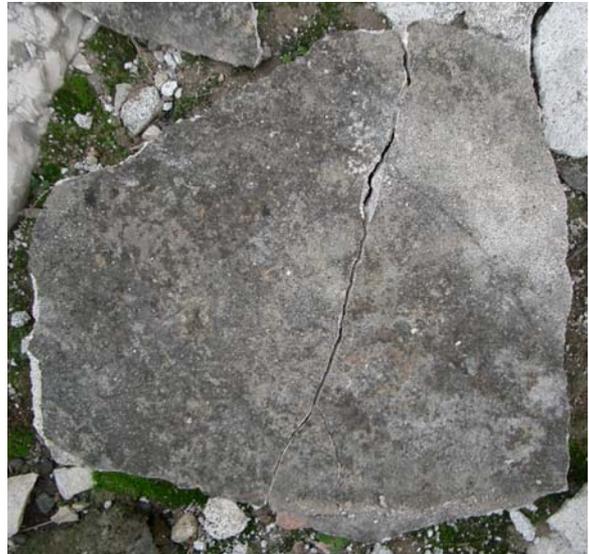
Fig. 3. *Above*: Edificio di Eumachia, June 2004. Detail. Incised drawings on the east wall in corridor 222.  
Fig. 4. *Below, to the left*: Edificio di Eumachia, December 2004. Large part of the decoration has fallen, and the remaining decoration is at risk.  
Fig. 5. *Below, to the right*: Edificio di Eumachia. One fallen incised drawing.
