## VI 6, 23 CASA DI PANSA

Sample no. 1

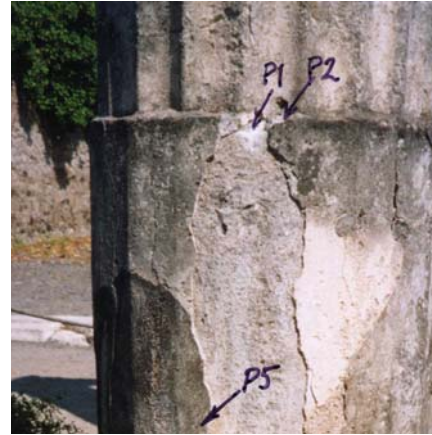
*Location* Peristyle. Column 2 from the NE.  
At the middle of the column shaft.

*Decoration* 1<sup>st</sup> style.

*Layer* Plaster and white stucco. First  
decoration covered by no. 2.

*Plaster* Black and white, lots of crystals

*Binder* Lots of lime.

*Filler* *Compact*: mainly black, irregular rounded. A few brown.

*Porous*: few porous red and bright yellow.

*Crystals*: long black, uncoloured, grey and olive green.

*Lime* Clean lime, lots of lime.

*Filler* Mainly large uncoloured, grey and yellow. Some small. Some bright yellow particles.

*Plaster type* **CP 1** **group A**

This plaster is similar to plasters used for 1<sup>st</sup> style decorations in the Temple of Jupiter (TJ3) and in the Temple of Apollo (TA1).

Stucco similar to that on the column in the south portico in the Temple of Apollo.

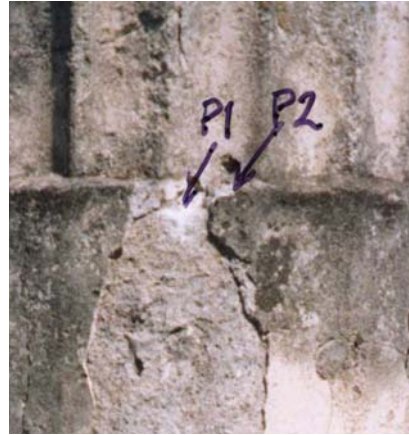
Sample no. 2

*Location* Peristyle. Column 2 from NE.  
At the middle of the column shaft.

*Decoration* 4<sup>th</sup> style decoration.

*Layer* Layer covering 1<sup>st</sup> style decoration.

*Plaster* Sandy plaster, lots of red

*Binder* Sandy lime.

*Filler* *Compact*: very small grains, black, brown, some yellow.

*Porous*: lots of small red.

*Plaster type* **CP 2** **group H**

Plaster typical of the 4<sup>th</sup> style.

*Same as TJ 2.*

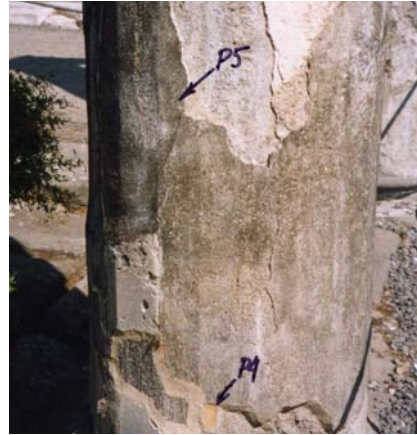
Sample no. 5

*Location* Peristyle. Column 2 from NE.  
At the middle of the column shaft.

*Layer* Layer covering the yellow decoration  
on the lower part of the shaft.

*Plaster* Sandy brown plaster

*Plaster type* CP 4

Same as no. 4.

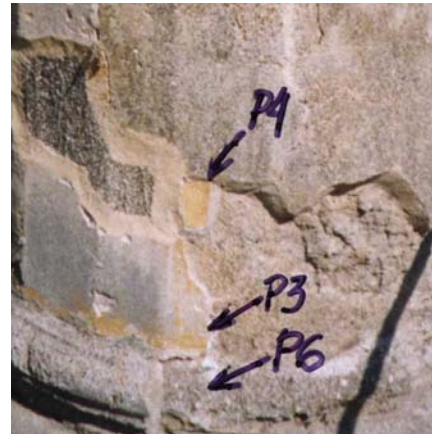
Sample no. 6

*Location* Peristyle. Column 2 from NE.  
Slightly above the base.

*Decoration* 1<sup>st</sup> style.

*Layer* First plaster layer.  
Covered by the decorated layer  
no.3.

*Plaster* Black and white, lots of crystals

*Plaster type* CP 1

Same as no. 1. The yellow decoration, sample no.3, has the same kind of plaster. This decoration is covered by a later phase, sample no.4.
