I 9, 3 Casa del Puer Successus

Sample no. 1

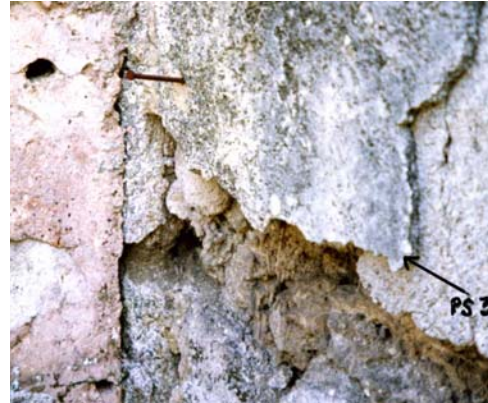
Sample no. 3

Plaster Many colours, lots of yellow

Binder Pale beige lime, a bit too much, with airbags and yellow lumps of lime.

Filler *Compact*: mainly small black, warm grey and brown grains 1-2 mm, between a few larger.

Porous: volcanic red, red-orange and yellow-orange. Some red "dust".

Crystalline: "broken black", uncoloured, grey, yellow, ca. 0.5 mm.

Plaster type **PS 3** (group E)

Solid plaster. Filler with warm colours. Large and small particles of irregular shape.

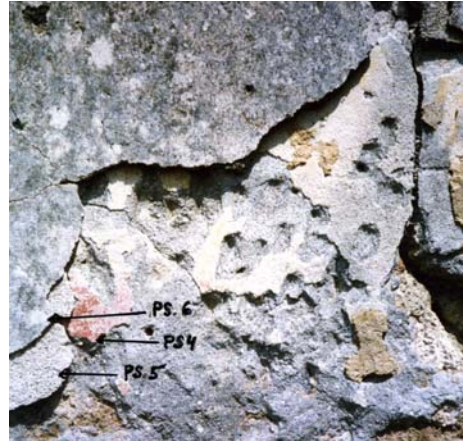
Sample no. 4
Room 10, east wall.
Location H. 1.65, 1.01 from the SE corner.
Decoration Decoration in red and yellow.
Layer Layer with pick-marks. Covered by PS 5.
Photo Film 4/15, 16.

Plaster Black and warm colours, small grains
Binder Beige lime with inclusion of extremely small particles.
Filler *Compact:* grey, dark grey and beige grains 0.5-1.5 mm.
Porous: volcanic red c. 0.5 mm.
Crystalline: "broken black", uncoloured, grey, yellowish, olive green.
Stucco ca. 2 mm.
Lime Yellowish lime
Filler Transparent uncoloured and yellowish small crystals.

Plaster type **PS 4** (group C)

Hard plaster. Extremely small particles between small grains. Particles of many colours. Red and yellow decoration. *Jan. 04:* OK. Black grains with red dots. Many crystals. Much filler, little lime with some lumps.

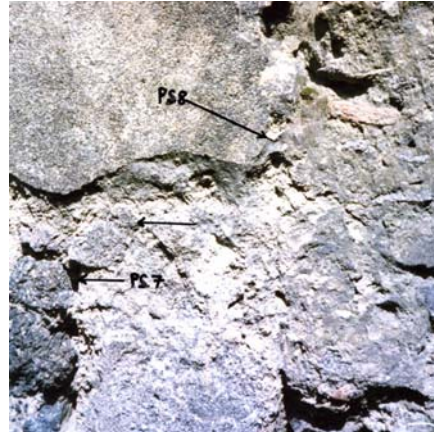
Sample no. 7
Room 12, east wall.
Location H. 1.17, 0.96 from the NE corner.
Decoration -
Layer Layer, seam, in the blocked door.
Covered by PS 8.
Photo Film 4/20.

Plaster type PS 1

Black and white. Rounded grains, some very large. A few olive green crystals.
Jan. 04: OK. Little lime. The same as PS 1.

Room 12: *Earliest phase:* Plaster type PS 1 (group A). E wall: plaster blocked behind later construction. Covered by plaster type PS 3.
Last phase: Plaster type PS 3 (group E). White plaster on areas on south wall, over SW corner, west and north walls, and continuing into room 11.

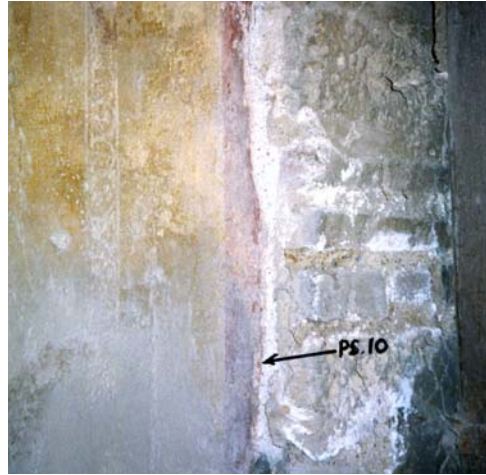
Sample no. 10
Room 5, south wall.
Location H. 1.53, at the window (left side).
Decoration 4th style decoration.
Layer Layer with decoration, covering all walls.
Photo Film 4/22.

Plaster Sandy plaster, lumps of lime
Binder Dirty lime with lumps of white lime.
Filler *Compact*: mainly small, black, warm grey, brown 0.5-1.5 mm.
Porous: volcanic red “dust” less than 0.5 mm.
Crystalline: “broken black”, yellow, green, less than 0.5 mm.
Stucco ca. 4 mm.
Lime
Filler Large and small crystals, uncoloured, beige and orange.

Plaster type **PS 10** (group H)

Hard plaster. Lots of very small grains, black and white, between black and beige large grains. Many crystals. Some lumps of lime. Black with red dots. Dirty plaster. Good proportion between lime/filler. Post earthquake? *Jan. 04*: -

Room 5: *First phase*: Plaster type PS 1 (group A). North wall: seam in a blocked opening. Covered by plaster type PS 10.
Last phase: Plaster type PS 10 (group H). 4th style decoration, yellow ochre walls and red socle with floral motifs, covering all walls.

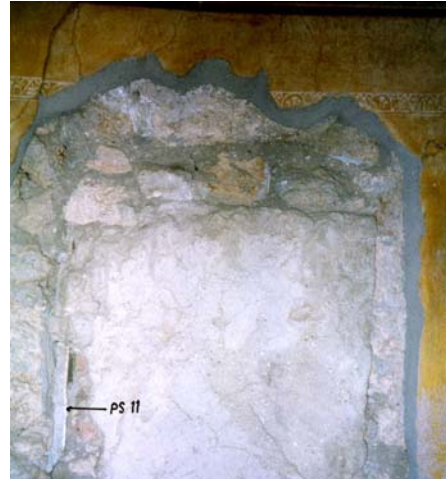
Sample no. 11

Plaster Black and white, lots of crystals
Binder Clean lime.
Filler *Compact*: mainly round, grey, beige c. 1-1.5 mm.
Porous: volcanic red and orange, less than 1 mm, few bright yellow lumps.
Crystalline: broken black, uncoloured, and a few small green.
Stucco ca 5 mm.
Lime White lime.
Filler Uncoloured and yellow crystals 0.5-2 mm.

Plaster type PS 1

Plaster with much filler, little lime. Good proportion large/small particles. Some very large.

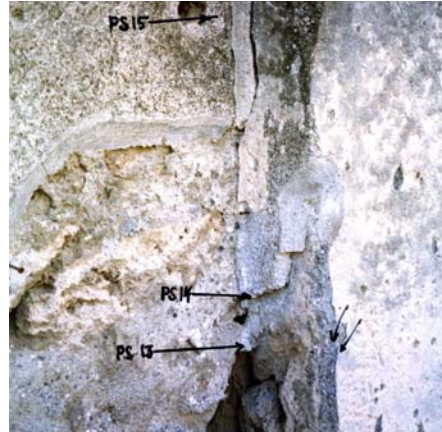
Sample no. 13

Plaster type PS 1

Small grains, black and white. No green crystals.

Jan. 04: OK. Filler with small rounded grains, black and white, some large. Little lime.

Room 2: *Earliest phase:* Plaster type PS 1 (group A). West wall: in the NW corner at the entrance to room 1. Covered by plaster type PS 4. East wall: blocked behind south wall. Covered by plaster type PS 4.

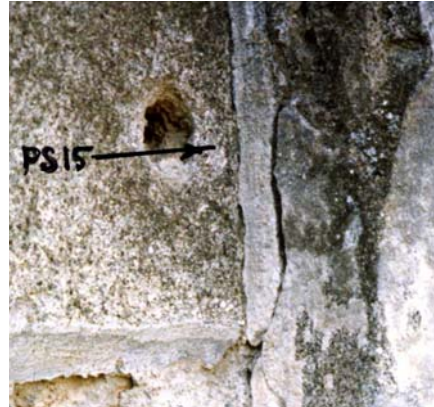
Sample no. 15

Plaster Sandy plaster, lumps of lime

Plaster type PS 10

Large and small particles. Unclean lime. The same as no. 17.

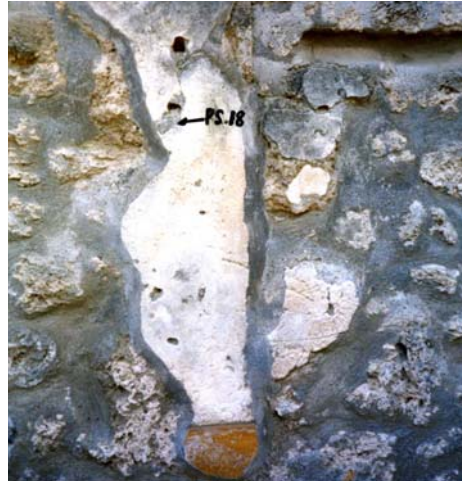
Sample no. 18
Room 1, west wall.
Location H. 1.36, 1.62 from the entrance
to room 2.
Decoration Small fragment
Layer Layer with decoration.
Photo Film 4/28

Plaster type PS 10

Notes
Dirty plaster
Jan. 04: OK

Room 1: *Last phase:* Plaster type PS 10 (group H). East wall: small remains of decoration, white walls and yellow ochre socle.

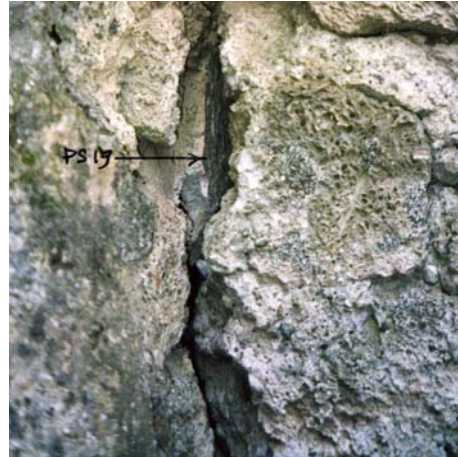
Sample no. 19
Room 10, south wall.
Location H. 1.37, at the SW corner.
Decoration Stucco layer.
Layer Layer with red decoration,
blocked behind west wall.
Photo Film 7/1.

Plaster type PS 2

Some very large grains. The same as PS 2, with “red stucco”, *cocciopesto* not pigment. This kind of red surface often appears at the socle zone, on garden walls, in service rooms – i.e. damp areas. *Jan. 04*: OK.

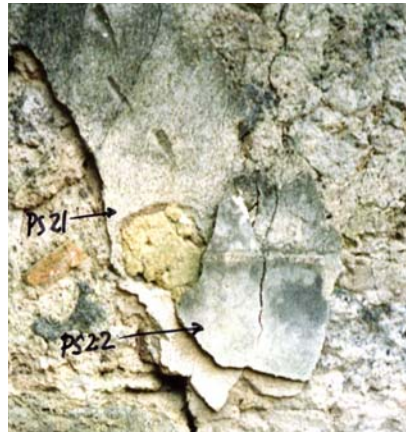
Sample no. 21
Room 10, east wall.
Location H. 1.30, 0.25 from the SE corner.
Decoration -
Layer Second layer, with pick-marks.
Covering PS 20 and covered by
PS 22.
Photo Film 7/3.

Plaster type PS 3

Beautiful! White lime, many colours. The same as sample 8. Rough layer, preparation for the decoration (sample 22).

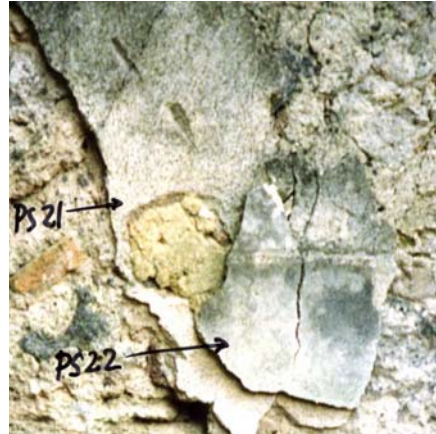
Sample no. 22
Room 10, west wall.
Location H. 1.10, 0.46 from the SW corner.
Decoration Black socle, white wall.
Layer Upper layer.
Photo Film 7/2.

Plaster type PS 3

Jan. 04: OK. Same as PS 6.

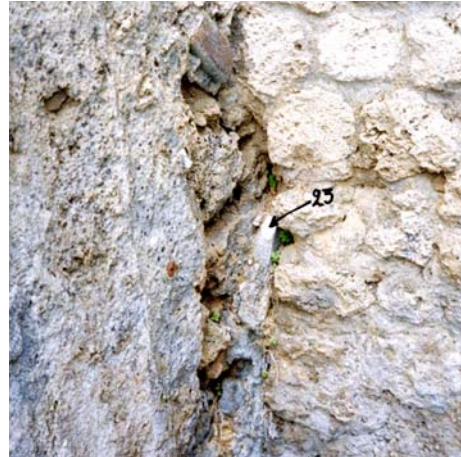
Sample no. 23
Room 8, NW corner.
Location H. 0.65.
Decoration Smooth surface, indicating decoration.
Layer Layer on the west wall continuing behind the north wall.
Photo Film 14; 10.

Plaster type PS 2

Much lime, yellowish. Fine grained, black grey, yellow and few bright yellow, all of same size. Few larger. Uncoloured and black crystals.

Room 8/9: *First phase:* Plaster type PS 2 (group B). West wall: layer blocked behind north wall.
Last phase: Plaster type PS 3 (group E). North wall, NE side: layer with decoration. Same phase on the column.

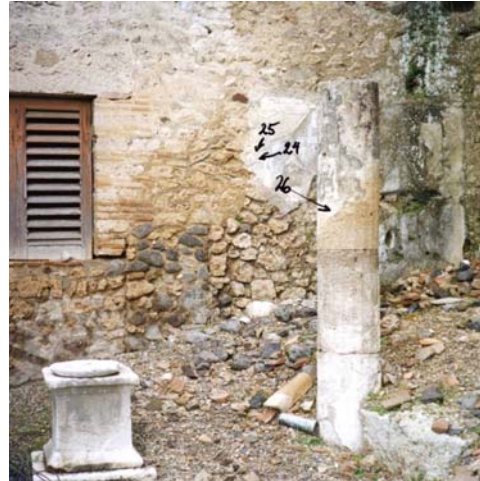
Sample no. 26
Room 8, column.
Location H.
Decoration
Layer
Photo Film 14; 9

Plaster type PS 3
