## I 9, 3 Casa di Puer Successus

## *I 9, 3 Plaster types, groups, locations*

I 9,3 Casa del Puer Successus (PS)

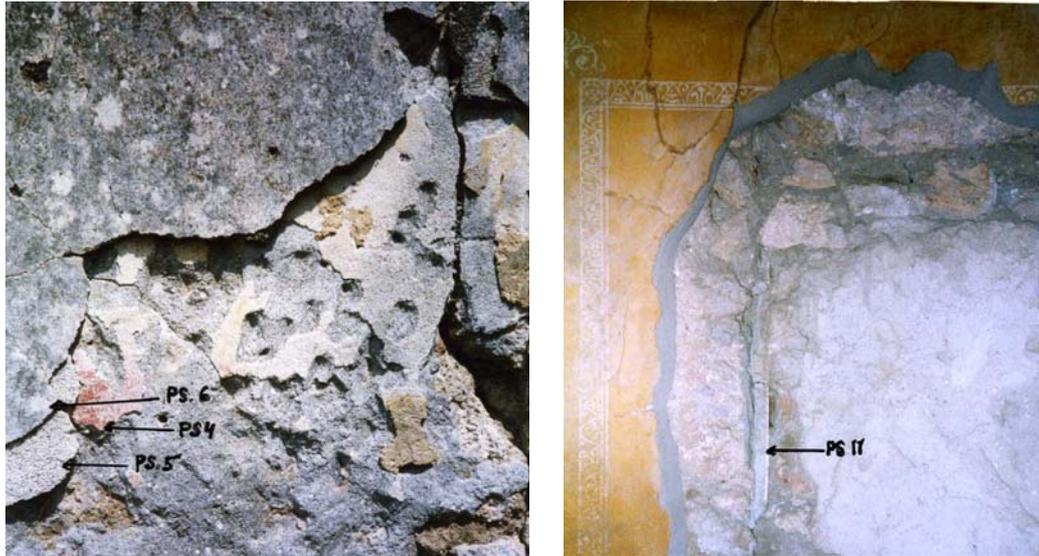
Fig. 15. To the left: Room 10, layers at the east wall. Fig. 16. To the right: Room 5, two decoration phases.

The first decoration on the east wall was a 2<sup>nd</sup> style painting, made on a plaster that belongs to group C (*Fig. 15*).<sup>3</sup> Fragments of the painting appear at many areas and in some cavities, suggesting niches, in the wall. The paintings’ surface was hacked with a pick-hammer before the successive decoration. Cutting marks in the smooth and hard surface would ensure a good adherence for the fresh plaster. In this case the new, and last, decoration was of the 3<sup>rd</sup> style, plaster group E. There are remnants of this painting on all walls. A partial, final application reaches approximately the height of one meter above the floor. At first I interpreted this layer as a repair at the socle level, but since the plaster is of the same kind as on the wall, only with slightly finer grains, it may just be another application at the socle zone, and consequently, was regarded as a finer grained plaster of group E.

In room 5, there is a closed in opening the north wall with remains of a 1<sup>st</sup> style decoration plaster type A (Fig. 16). This opening was closed during the late history of the house as indicated by the plaster, type H. The opening is partially visible, since the painting, showing a little boy with a duck, which covered this space, is now in the Museum in Naples. A graffito on the painting, Puer Successus, has given the name to this house.<sup>4</sup> Plaster type H, containing *cocciopesto* and crushed materials, was used for the 4<sup>th</sup> style decoration in this and other rooms in the atrium area.<sup>5</sup>

*Third phase:* type PS 4, group C. East wall: remains of yellow and red decoration, layer with pick-marks.
